**UNITED STATES DISTRICT COURT
NORTHERN DISTRICT OF CALIFORNIA**

W.C. and W.D.)	Case No.
)	
Plaintiffs,)	COMPLAINT AND
)	DEMAND FOR JURY TRIAL
v.)	
)	
CHART INC.)	
)	
Defendant.)

INTRODUCTION

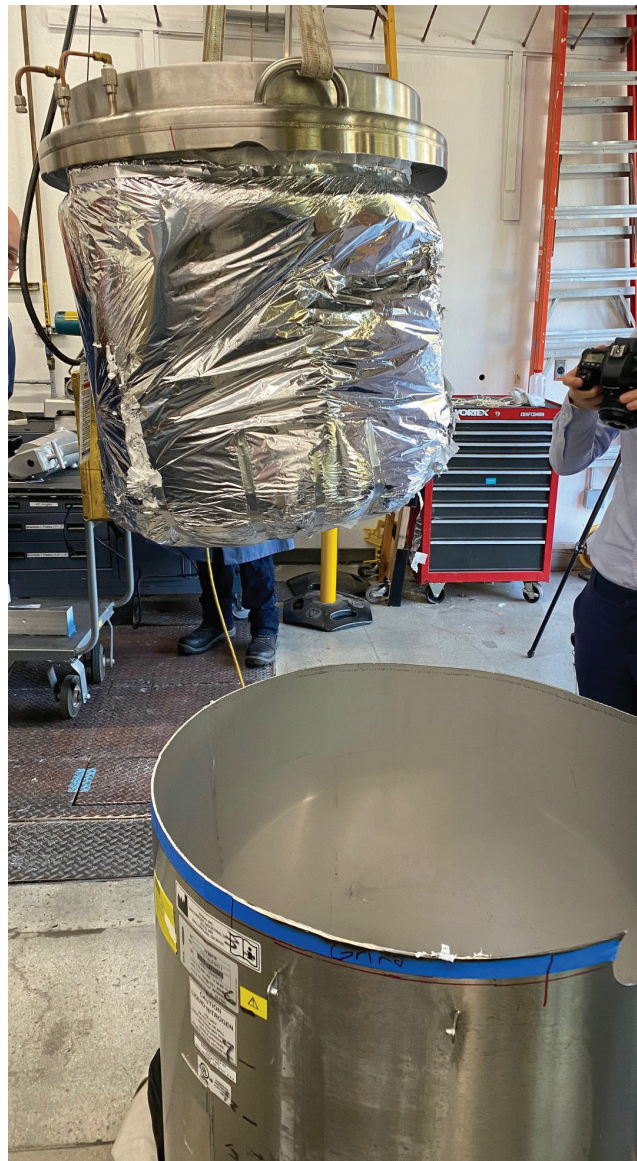
19. The picture below was taken following failure of Tank 4 and shows the tank's inner vessel (wrapped in reflective material) being removed from the outer vessel. In between the two vessels was an interstitial space. Before a tank is put into service, Chart draws a vacuum within that space by sealing it shut and pumping out the air. The resulting vacuum space is what allows cryopreservation tanks to keep liquid nitrogen and biological samples at -198°C .

Tank 4's inner vessel suspended after removal from outer vessel (vacuum space was in between)

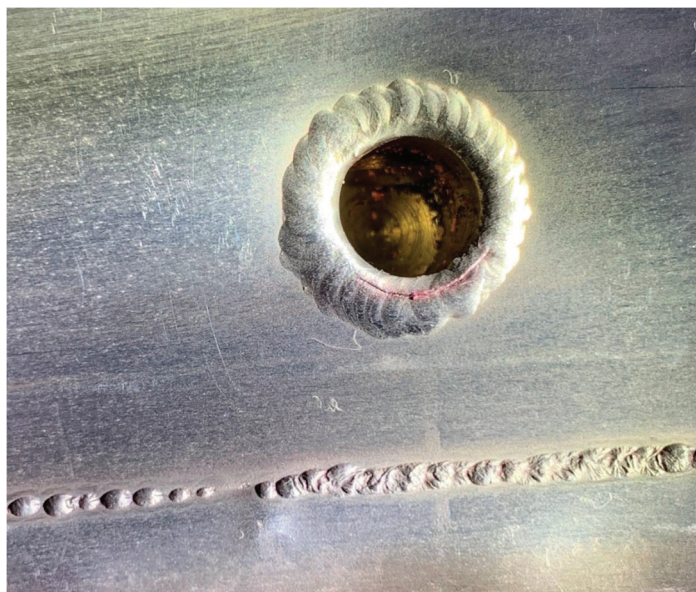
5 27. The image on the right is the same weld, this time after using Magnaflux Spotcheck
6 liquid dye penetrant. The fact the red dye penetrant remained after the surface was wiped clean is
7 indicative of a crack.

Red dye indicates a crack in the weld
